Report No. 8926-124

Material - Aluminum - 2024-T81 and 2024-T31 -Stretcher Levelled Plate

Stress Corrosion Susceptibility From Rivet Swelling

REPORT NO. 57-506 STRESS CORROSION CRACKING TEST OF 2024-T81 ALUMINUM ALLOY PLATE

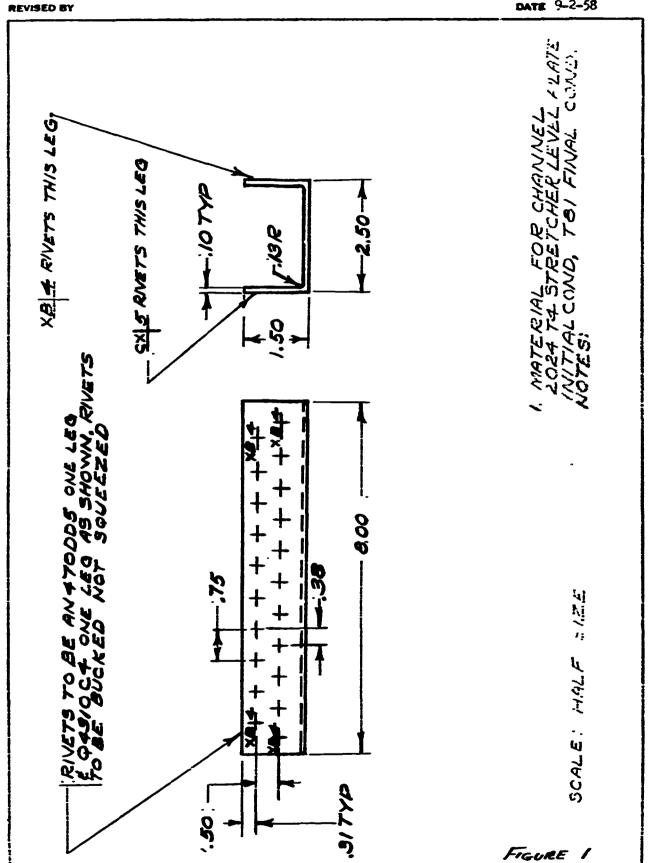
Specizens were taken from a 2 in. thick plate of 2024-T4 stretcher leveled plate. Four pieces 2 3/4 in. x 8 1/4 in. were cut from this plate with the longitudinal dimension parallel to the grain direction. Each of these was machined to a channel section, heat treated, drilled, and riveted in accordance with Figure 1.

Rivet holes were drilled in accordance with Convair Standard \$2001. This requires that the holes for the 5/32 in. universal head 2024-T31 rivets be .161 -.036 in. diameter and the holes for the 1/8 in. flat head stainless steel rivets be .128+.006 in. diameter. The diameter of the 5/32 in. rivets is .156 $^{+.004}_{-.001}$ and of the .125 in. rivets is .125 $^{+.003}_{-.001}$. Rivets were driven with a gun rather than a squeezer.
